Early, reliable fault detection is paramount for wind turbines

Case Story – Wind turbine coupling defect

A 2 MW wind turbine is monitored using the remote monitoring and diagnostic service provided by Brüel & Kjær Vibro's Surveillance Centre in Denmark. A coupling defect was detected with more than a half-year lead-time to repair, using the adaptive monitoring strategy and the alarm manager functionality.

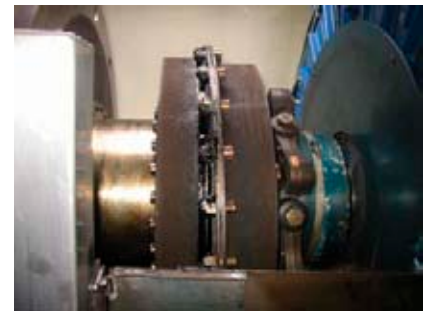
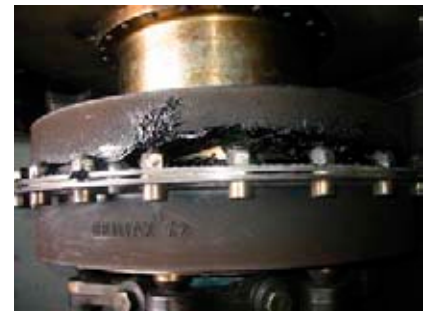
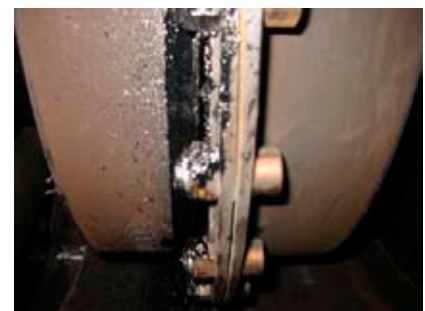
Figure 1 Damaged coupling.

The unchanged generator DE upper bandpass frequencies suggest there is no problem with the bearing. Simultaneous increase of the generator DE and NDE 1st order magnitude indicates rotor unbalance. The increasing 3rd stage gearbox overall vibration indicates the problem is related to the generator-gearbox coupling.

Figure 1 shows a damaged coupling half on the gearbox side of the coupling. The trend plot in Figure 2 shows the 1st order magnitude vibration trend both before and after servicing the coupling. ■

Inspect the generator rotor, coupling and DE/NDE bearings for loose components.

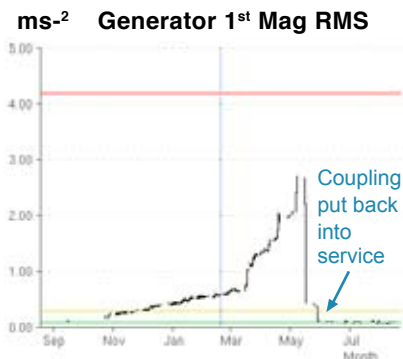
There was an increase in the generator driven end (DE) 1st order magnitude that exceeded the Alert limit in power classes 3, 4, and 5 (see Figure 2). There was also an increase in the generator DE overall vibration and the generator non-driven end (NDE) 1st order magnitude, but below the Alert limit. In addition to this, there was also a small increase in the generator DE 2nd order magnitude (below the Alert limit) and an increase in the 3rd stage gearbox overall vibration for the same power classes.

Figure 2 Generator driven end accelerometer vibration amplitude exceeds the Alert alarm limit. The vibration amplitude after repair is shown on the right side of the plot.

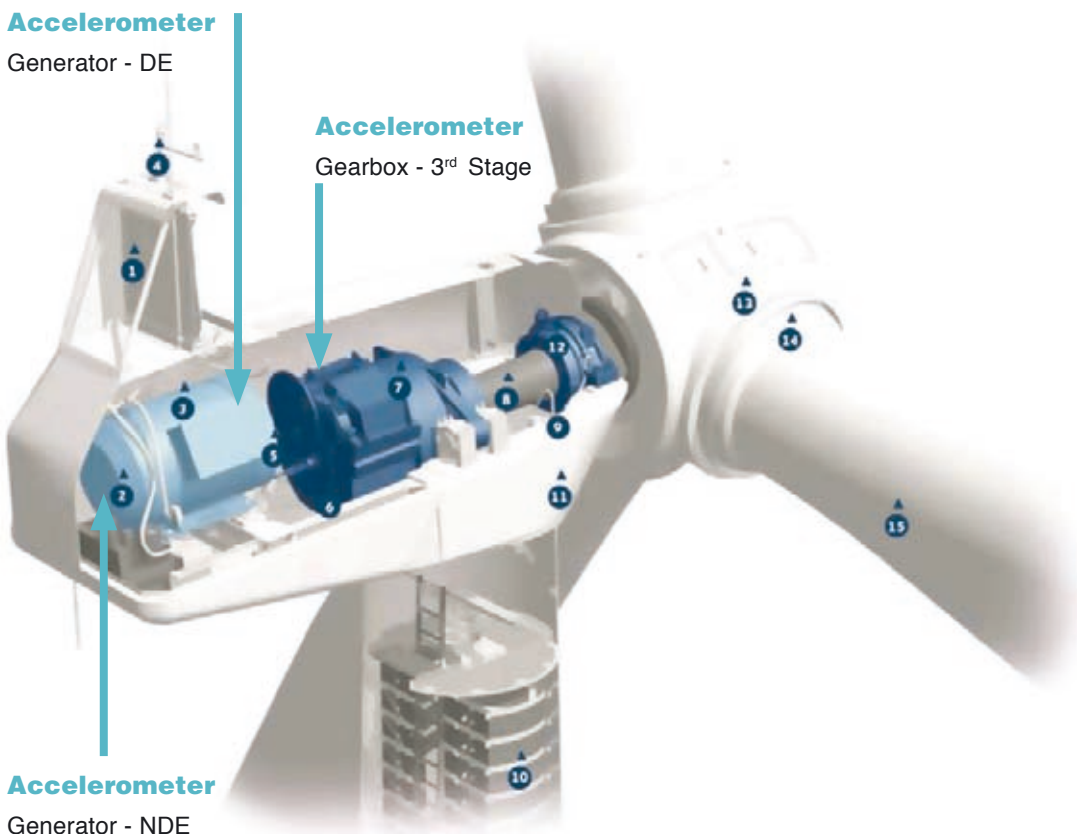
Figure 3 The three accelerometers shown have signals that exceeded alarm limits or showed significant change in the case story. The numbers in the drawing refer to the wind turbine components. Those components that are applicable to the case story are the generator (2), coupling (5) and gearbox (7).
